Manhole Inspection Summary

Manhole # S31SS_015MH

Location Address: **501 HAMDEN AVE**

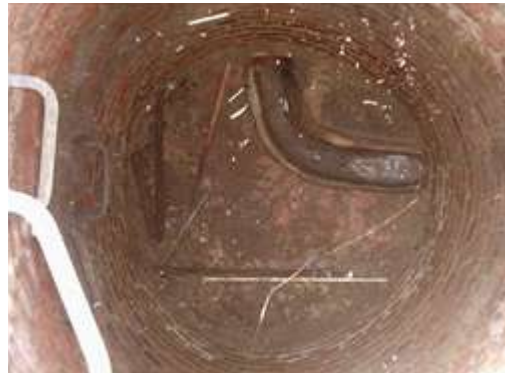
Top View

Barrel infiltration. Corroded steps.
Evidence of surcharge - Bench debris.
Channel debris.

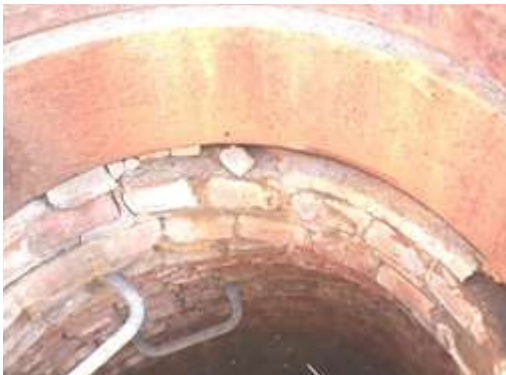
Defect

Frame leaks. Adjustment deterioration,
loose brick and infiltration. Corbel
infiltration.

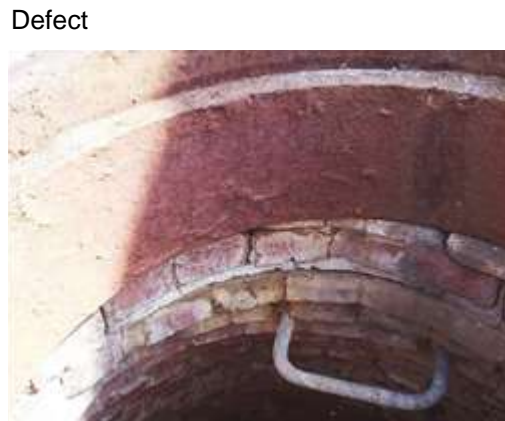
Frame leaks. Adjustment deterioration,
loose brick and infiltration. Corbel
infiltration.

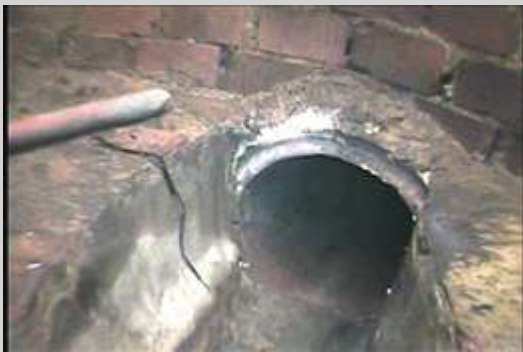
8 in. Circular Gravity Sewer Pipe Out @ 12 O'Clock

Infiltration: **Evidence** Pipe Seal Cond: **Unknown**

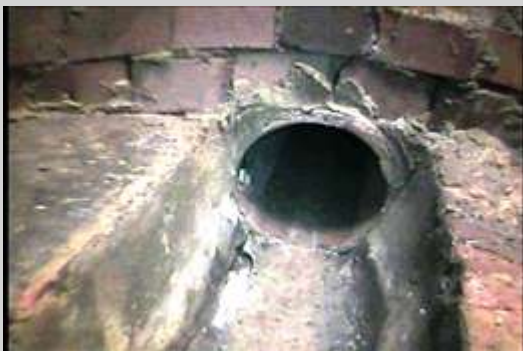
6 in. Circular Gravity Sewer Pipe In @ 3 O'Clock

Channel crack.

Infiltration: **Evidence** Pipe Seal Cond: **Cracked**
